Manhole Inspection Summary

Manhole # S31OO1020MH

Location Address: **4501 CHARLES ST**

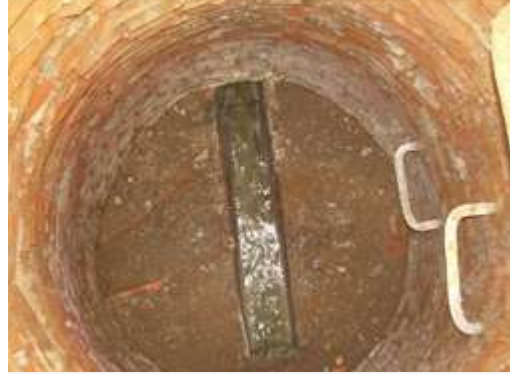
Top View

Evidence of surcharge - Bench debris.
Channel debris.

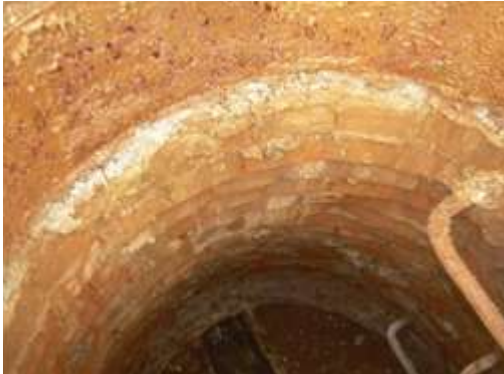
Defect

Frame leaks. Adjustment deterioration
and infiltration. Barrel infiltration.

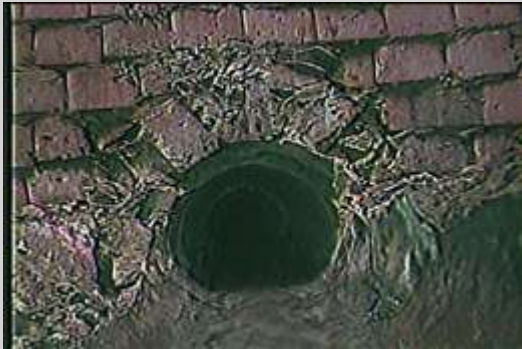
8 in. Circular Gravity Sewer Pipe Out @ 12 O'Clock

Channel deterioration.

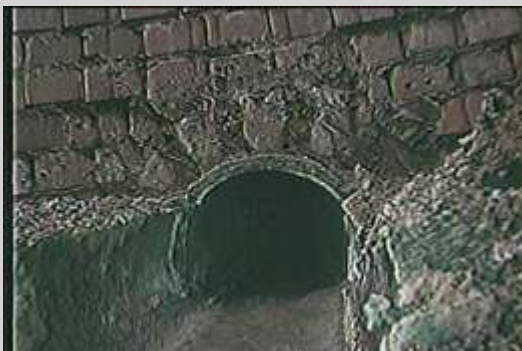
8 in. Circular Gravity Sewer Pipe In @ 6 O'Clock

Barrel deterioration and infiltration.

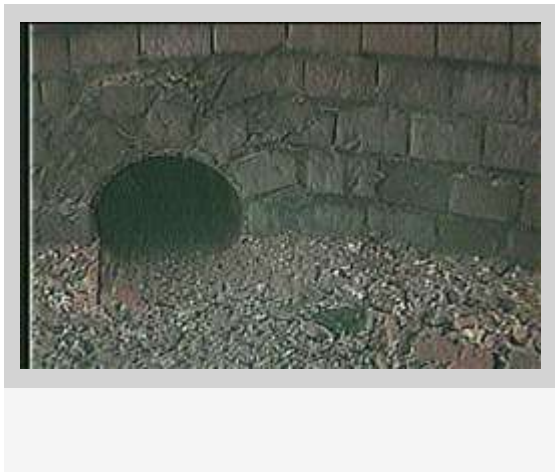
Pipe In @ 9 O'Clock

Pipe Material: ☐ Pipe Lined
Invert Depth: (ft.) Flow Characteristics: **None**
Deposits: ☐ None ☒ **Mud** ☐ Sludge ☒ **Debris** ☐ Grease
Silt Depth: **1** (in.) Deposits Extent: **Light**
Infiltration: **None** Pipe Seal Cond: **Unknown**

Connects To: **Stub connection / abandoned**
☐ Possible Illicit Connection
